Debris/Ice/TPS Assessment and Integrated Photographic Analysis of Shuttle Mission STS-86

**DEBRIS/ICE/TPS ASSESSMENT
AND
INTEGRATED PHOTOGRAPHIC ANALYSIS
OF
SHUTTLE MISSION STS-86**

25 September 1997

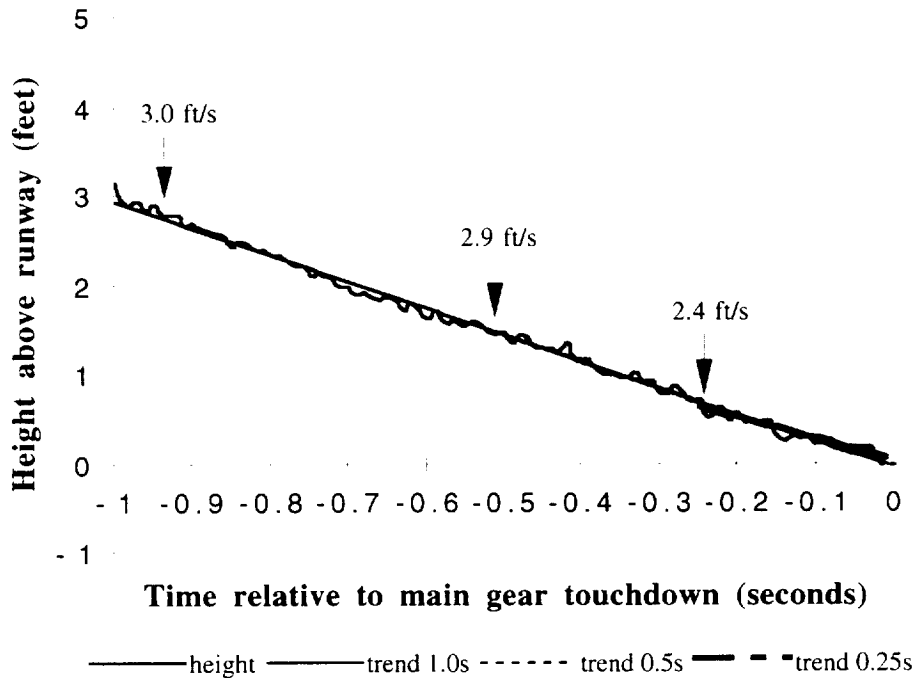
Figure 2.6.1 (A) Main Gear Height versus Time Prior to Touchdown

The measured main gear sink rate values were found to be below the maximum allowable values of 9.6 ft/sec for a 211,000 lb. vehicle and 6.0 ft/sec for a 240,000 lb. vehicle (the landing weight of the STS-86 Orbiter was reported to be 214,726 lbs). The sink rate measurements for STS-86 are given in Table 2.6.1. In Figure 2.6.1 (A), and 2.6.1 (B), the trend of the measured data points for the image data is illustrated.
